Manhole Inspection Summary

Manhole # S25AA2005MH

Insp Date: **10/31/06 11:27 AM**

Location Address: **5500 ROLAND AVE**

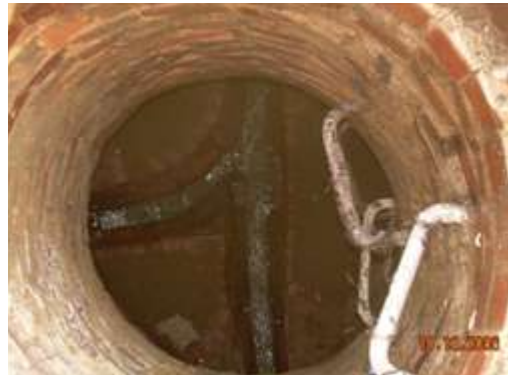
Top View

Frame leaks. Evidence of surcharge - Bench debris.

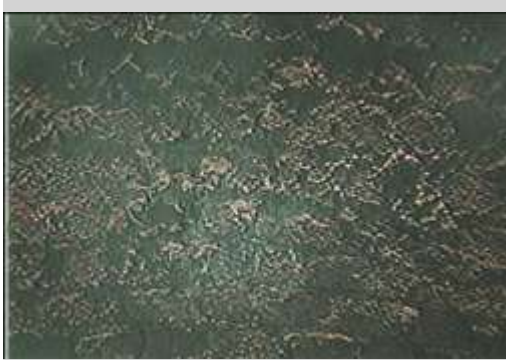
Defect

Barrel deterioration and infiltration.

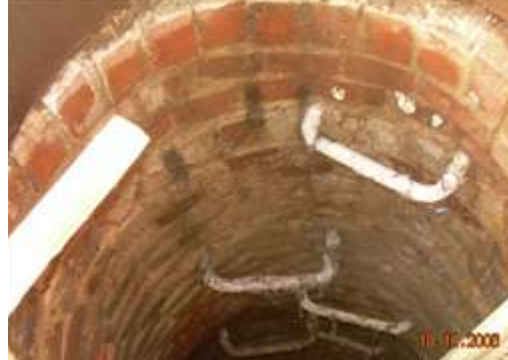
Defect

Frame leaks. Frame offset. Adjustment deterioration and infiltration. Corbel infiltration.

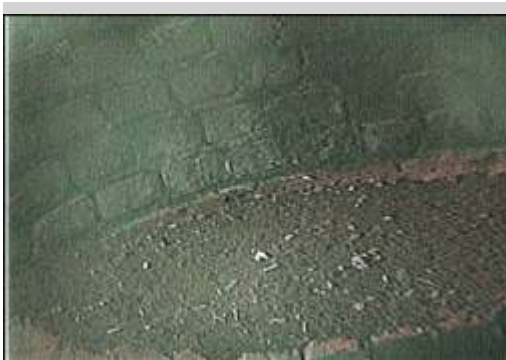
Defect

Barrel deterioration and infiltration.

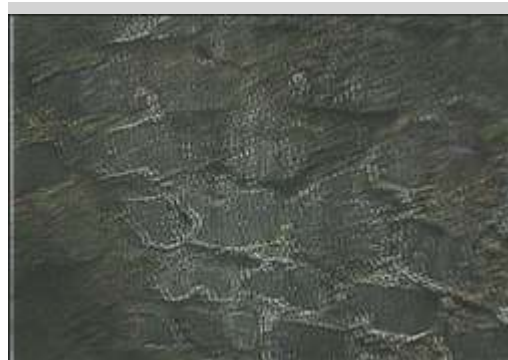
Defect

Corbel deterioration and infiltration.

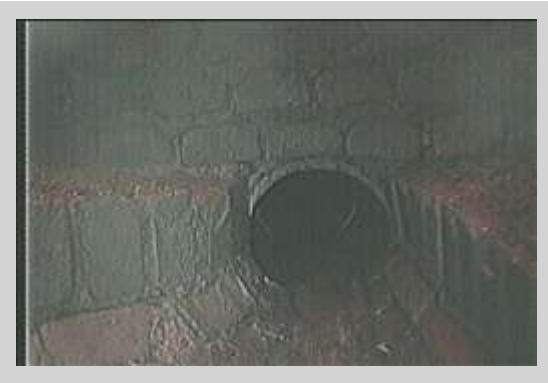
8 in. Circular Gravity Sewer Pipe Out @ 12 O'Clock

Barrel deterioration and infiltration. Channel deterioration.

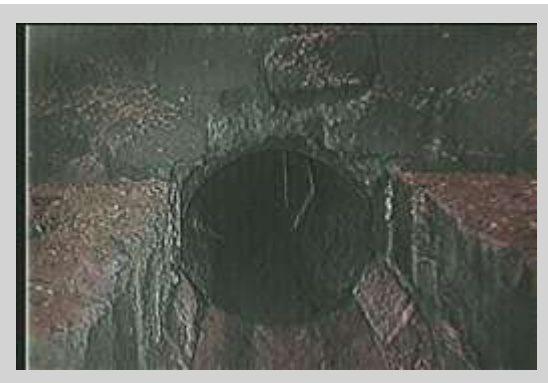
8 in. Circular Gravity Sewer Pipe In @ 6 O'Clock

Infiltration: **Evidence** Pipe Seal Cond: **Unknown**

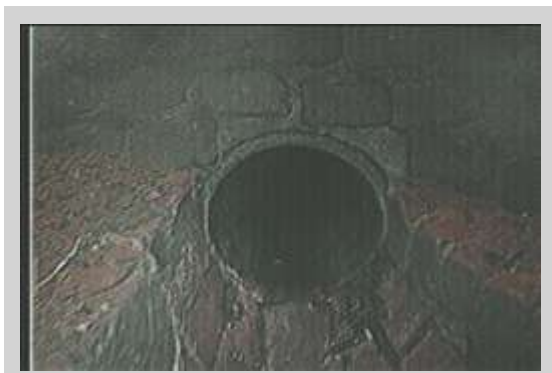
Pipe In @ 9 O'Clock

Barrel deterioration and infiltration. Channel deterioration.

Infiltration: **Evidence**
